Uptown is a compact African-American neighborhood in Hertford, North Carolina bordering the westside of the commercial district. Few people use the term Uptown nowadays, but older folks who remember the town of fifty-plus years ago know the Uptown neighborhood. It was walkable, close to worksites such as the mills on the Perquimans River.

Present-day Uptown has a neglected feel. Many houses have been abandoned and fallen into disrepair. Some have boarded-up windows and “Do Not Enter” signs posted. Too many are considered non-contributing to this once-vibrant historic district for all of the Uptown area to be considered for historic district status. Thus this application identifies a segment of the Uptown community for this Study List Application hereinafter referred to as “Uptown West.”

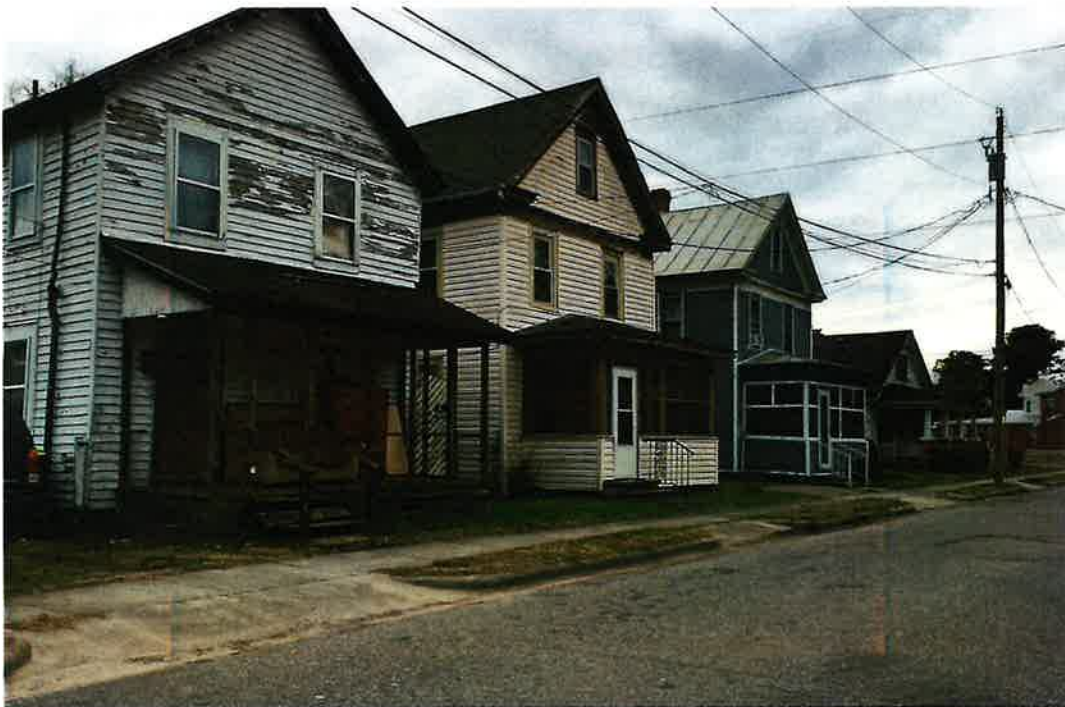
A section of Dobbs Street showing the predominant house form in Uptown Hertford

The neighborhood has a unified feel due to the homes of wood frame construction sharing characteristics of two stories with steeply pitched roofs, gable ends facing the street. This house plan is found elsewhere in Hertford and also in nearby communities

In the middle of the 400 block of Dobbs are several houses that bear a striking resemblance to one another: two-story frame construction with street-facing gable. Built in the 1960s, they contribute to the cohesive feel of Uptown West.
